COMMON PROPERTY SAFETY REPORT

Inspection date: 2 May 2025

HUNTERFORD ESTATE PENNANT HILLS ROAD, OATLANDS :: DP270218

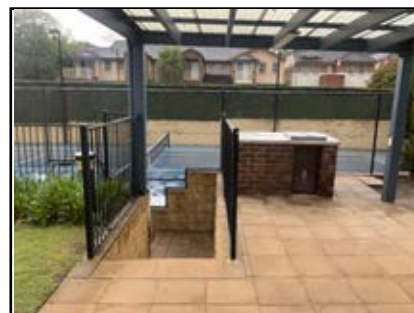
1. Balustrades appear inadequate.

It appears there may be inadequate handrails to provide support to the people using the stairs which may result in a fall hazard.

General Location: Staircase to the tennis court

Control measures: The provision of handrails should be considered to provide more support to people using access ways, stairs and the like.

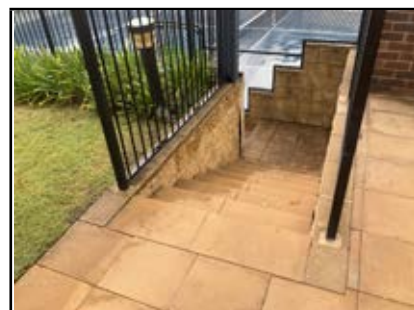
2. Trip hazards are present in the access way.

The stairs are not highlighted with illuminated paint which may increase the risk of a trip hazard.

General Location: Staircase to the tennis court

Control measures: Apply illuminated & anti-slip treatment on the stair treads to reduce this risk. In the long term, ensure the subject area is regularly and properly maintained and repaired.

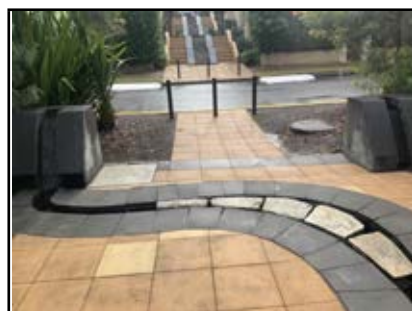
3. Trip hazards are evident.

The garden runnels appear to create uneven surfaces in the access way which may increase the risk of a trip hazard.

General Location: The garden near the nature park on Brookside Place

Control measures: Highlight the edge of the tiled edge with illuminated paint to improve visibility.

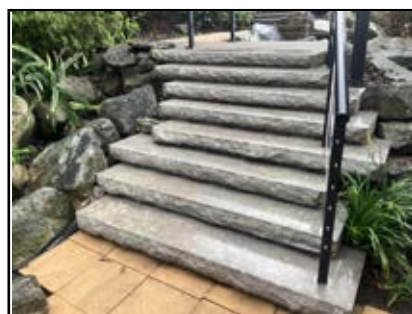
4. Trip or slip hazards are apparent in the access way.

Illuminated paint and anti-slip treatment do not appear to be applied on the stairs which may increase the risk of a trip or slip hazard.

General Location: The stone staircase near Brookside park

Control measures: Apply illuminated & anti-slip treatment on the stair treads to improve visibility. In the long term, ensure the subject area is regularly and properly maintained and repaired.

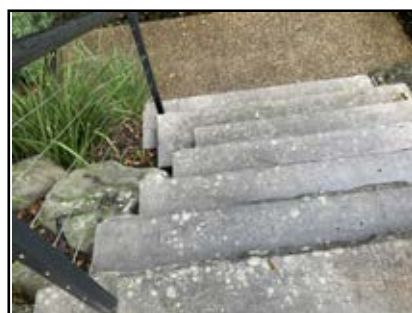
5. Trip hazards are evident.

Our inspection revealed the uneven spacing of the stairs may increase the risk of a trip hazard.

General Location: The stone staircase near Brookside park

Control measures: Apply illuminated & anti-slip treatment on the stair treads to improve visibility. In the long term, ensure the subject area is regularly and properly maintained and repaired.

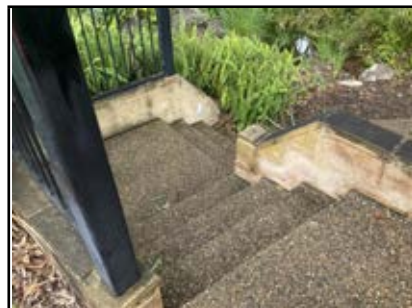
6. Trip hazards are present in the access way.

The stairs are not highlighted with illuminated paint which may increase the risk of a trip hazard.

General Location: External staircases

Control measures: Apply illuminated & anti-slip paint on the stair treads to reduce this risk. In the long term, ensure the subject area is regularly and properly maintained and repaired.
